Situation Photo Log

Wednesday, January 2, 2013

Kalamazoo River / Enbridge Spill

Water / Sediment Temperatures

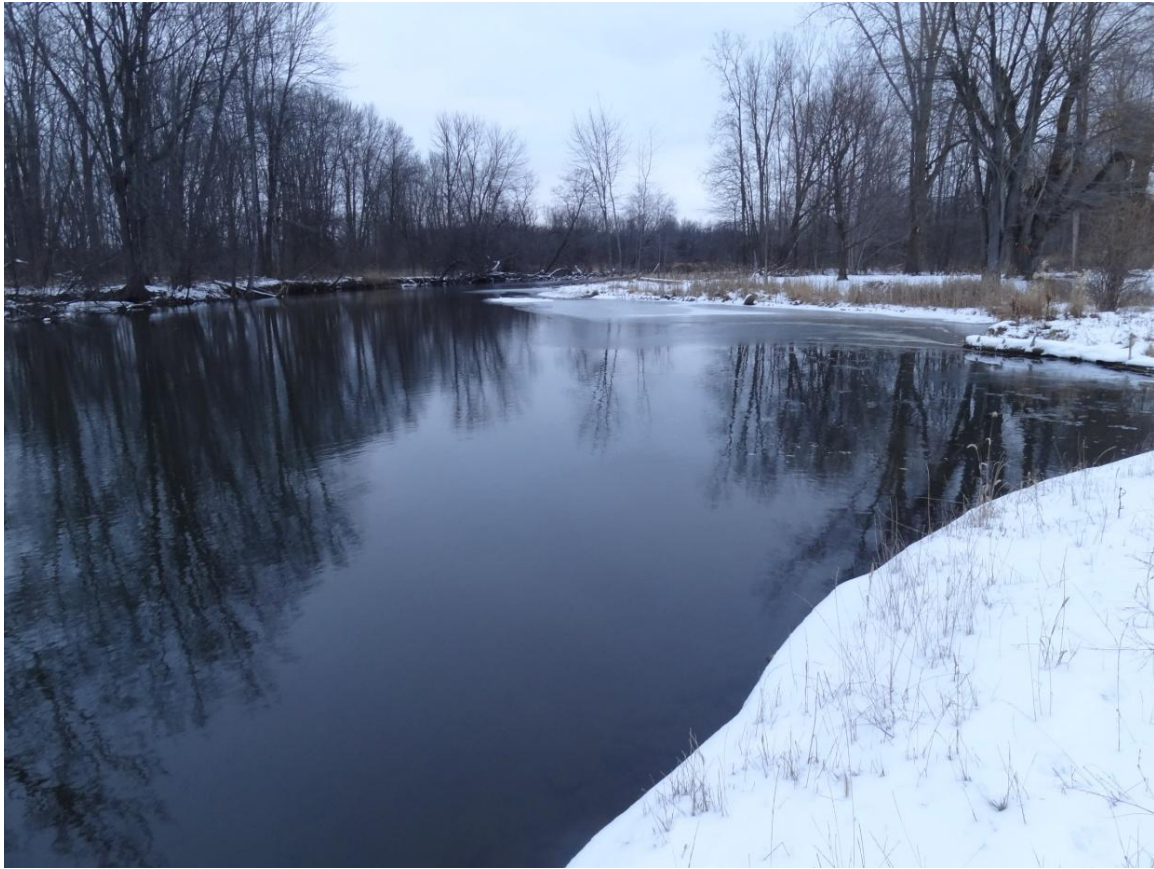
1. Confluence, bank ice observed has decreased from previous days.

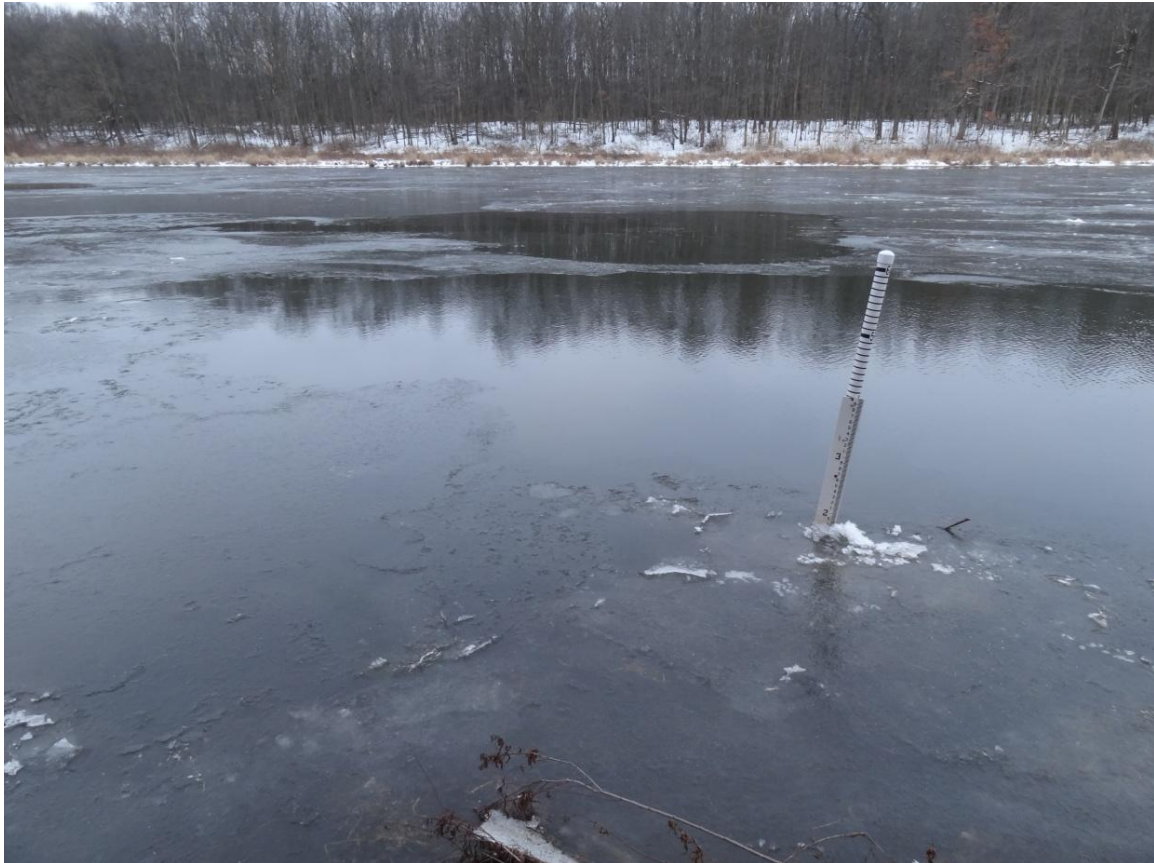
2. Water gauge at C0.4 Boat Launch. Ice observed along both river banks and in channel.

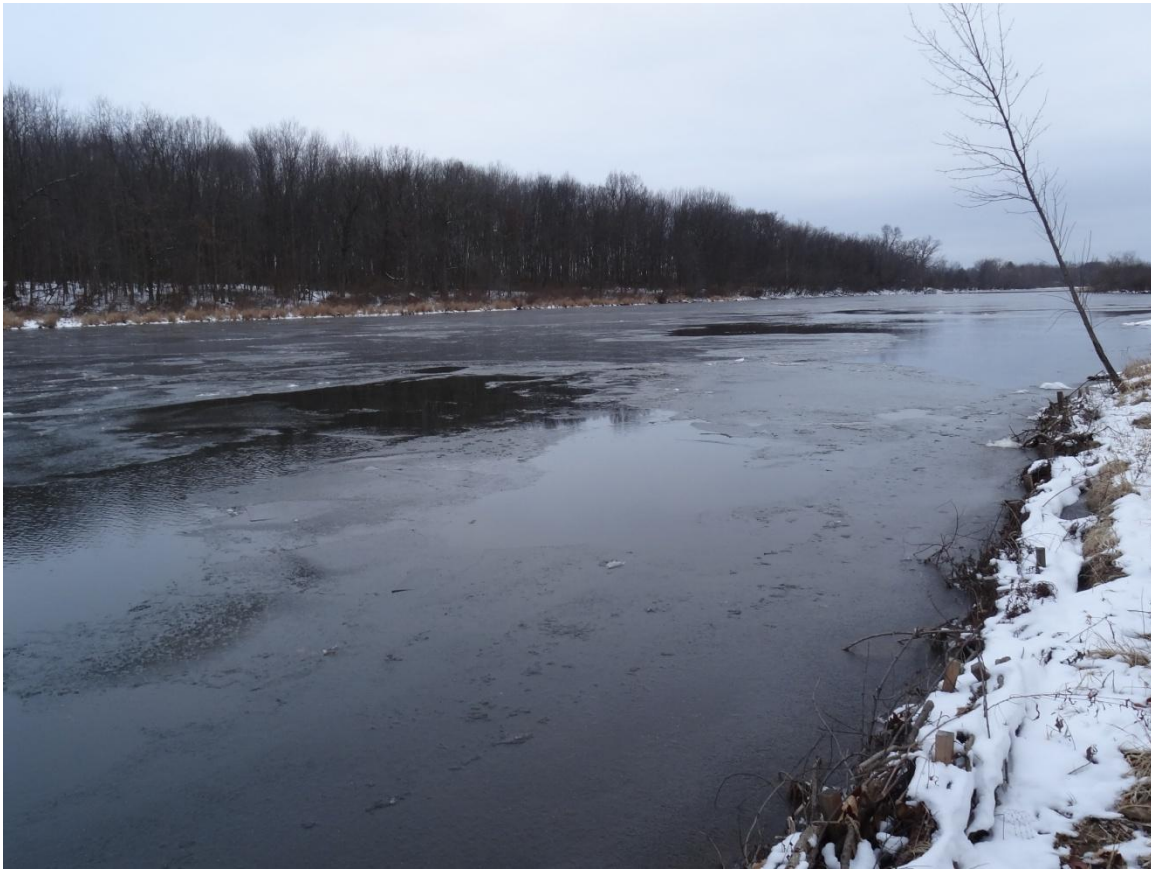
3. MP5.20 ice observed along river channel.

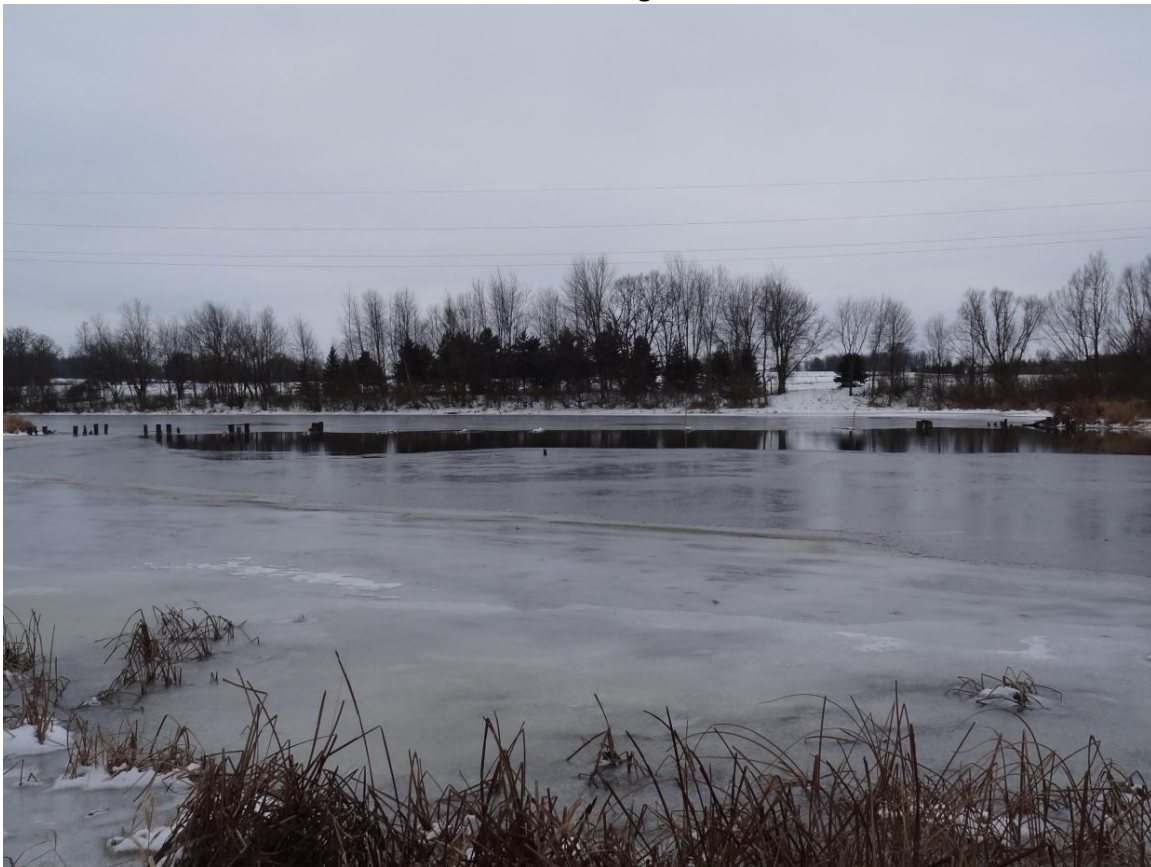
4. MP5.63 Ceresco Dam trestles, ice observed along both river banks. River channel remains open.

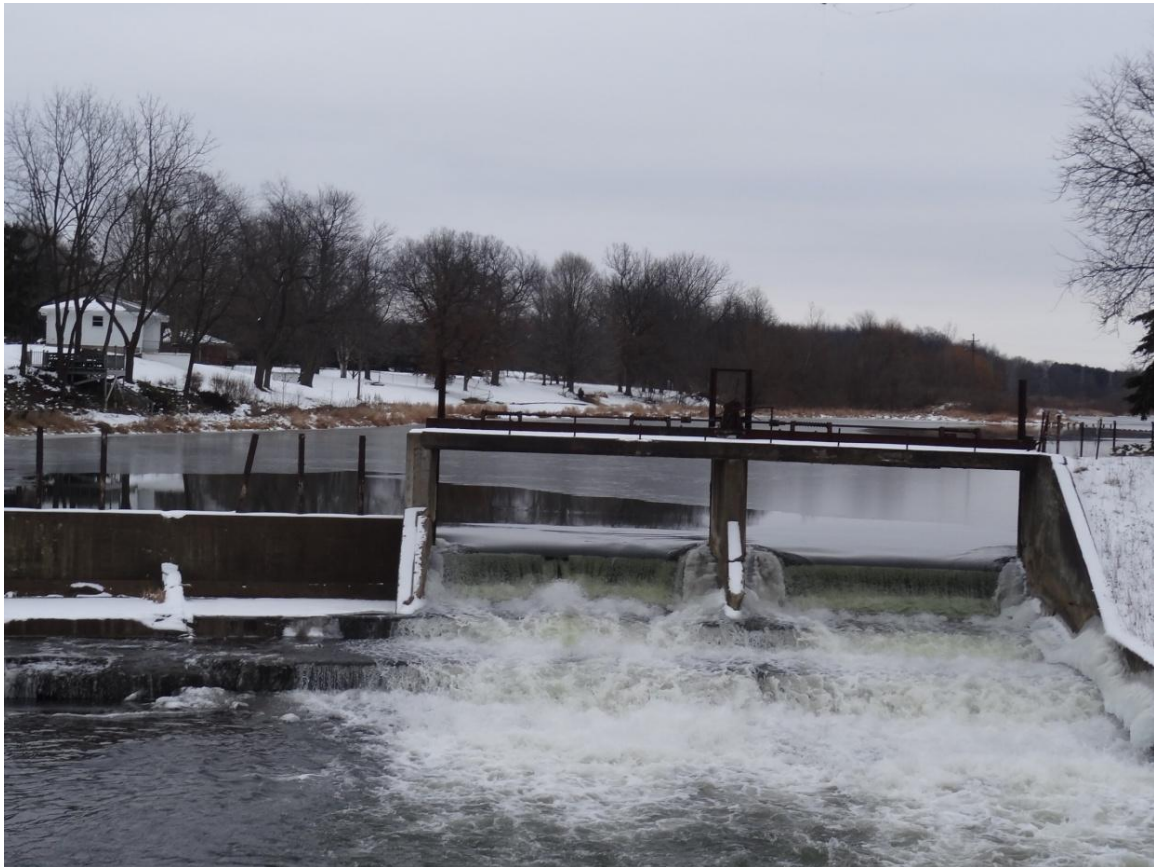
5. Ceresco Dam, no ice observed flowing over spillway.

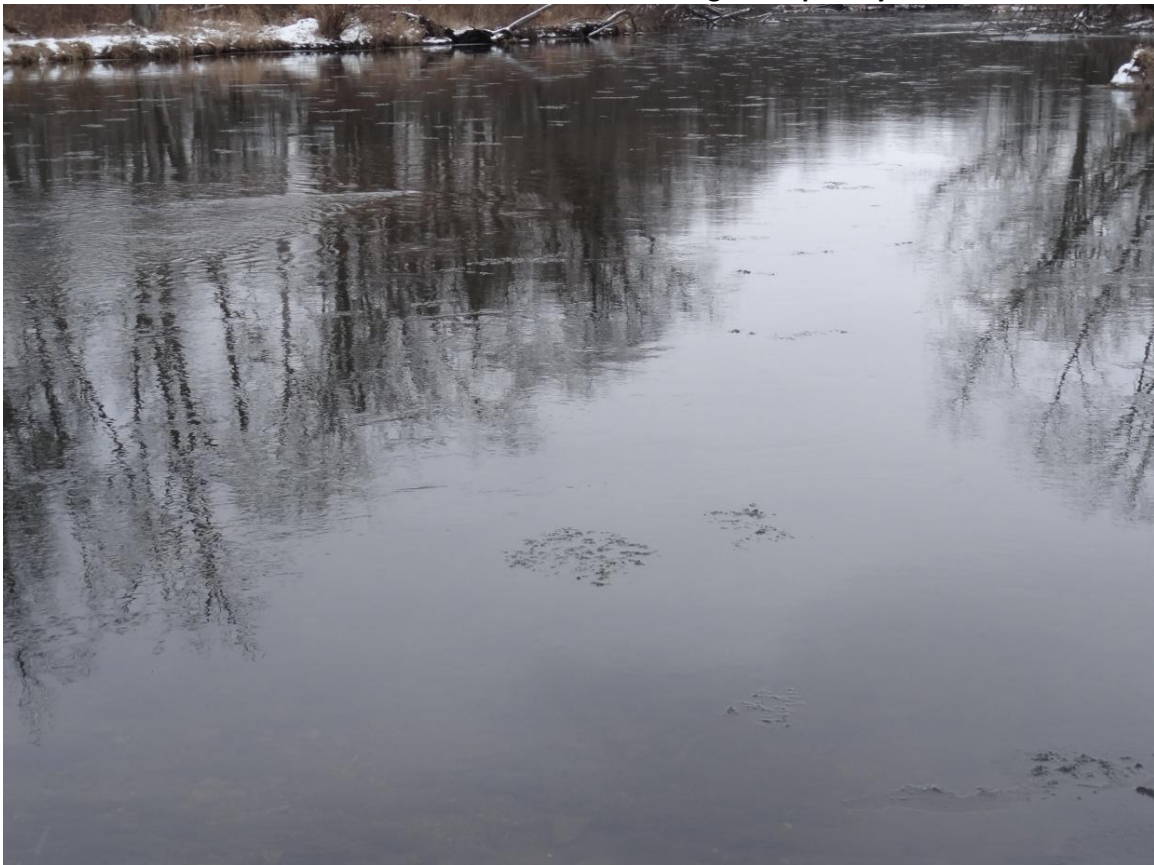
6. C3.2 Boat Launch, small patches of frazil ice observed flowing downstream in river channel.

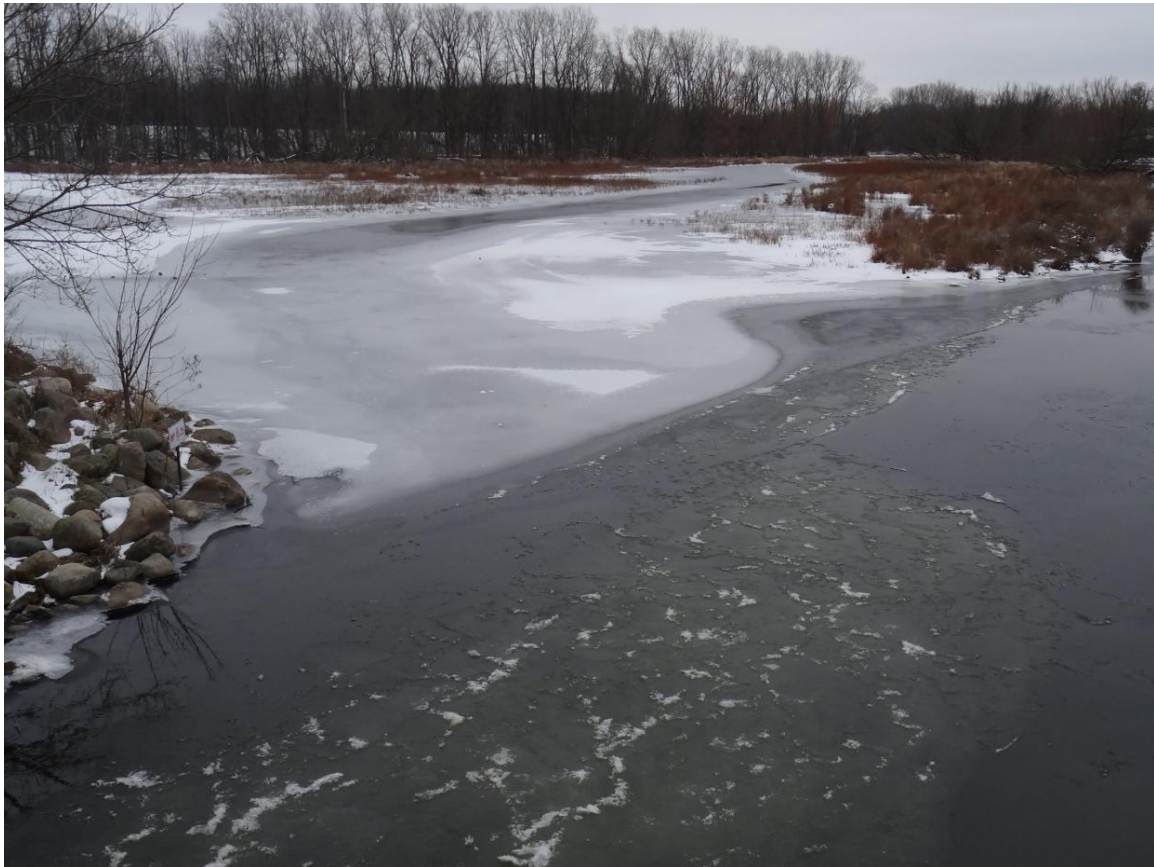
7. MP15.25 South Mill Pond. Frazil ice observed flowing downstream in river channel.

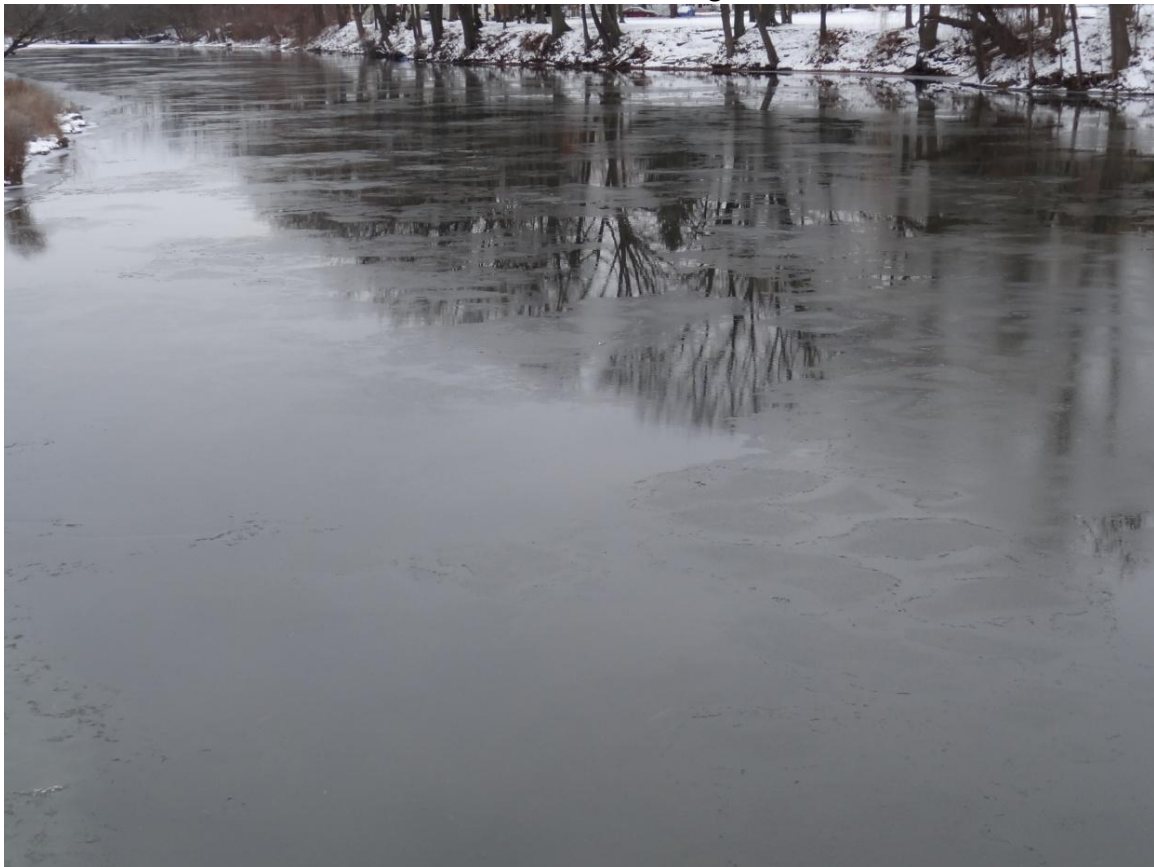
8. MP15.25 frazil ice observed flowing downstream in river channel.

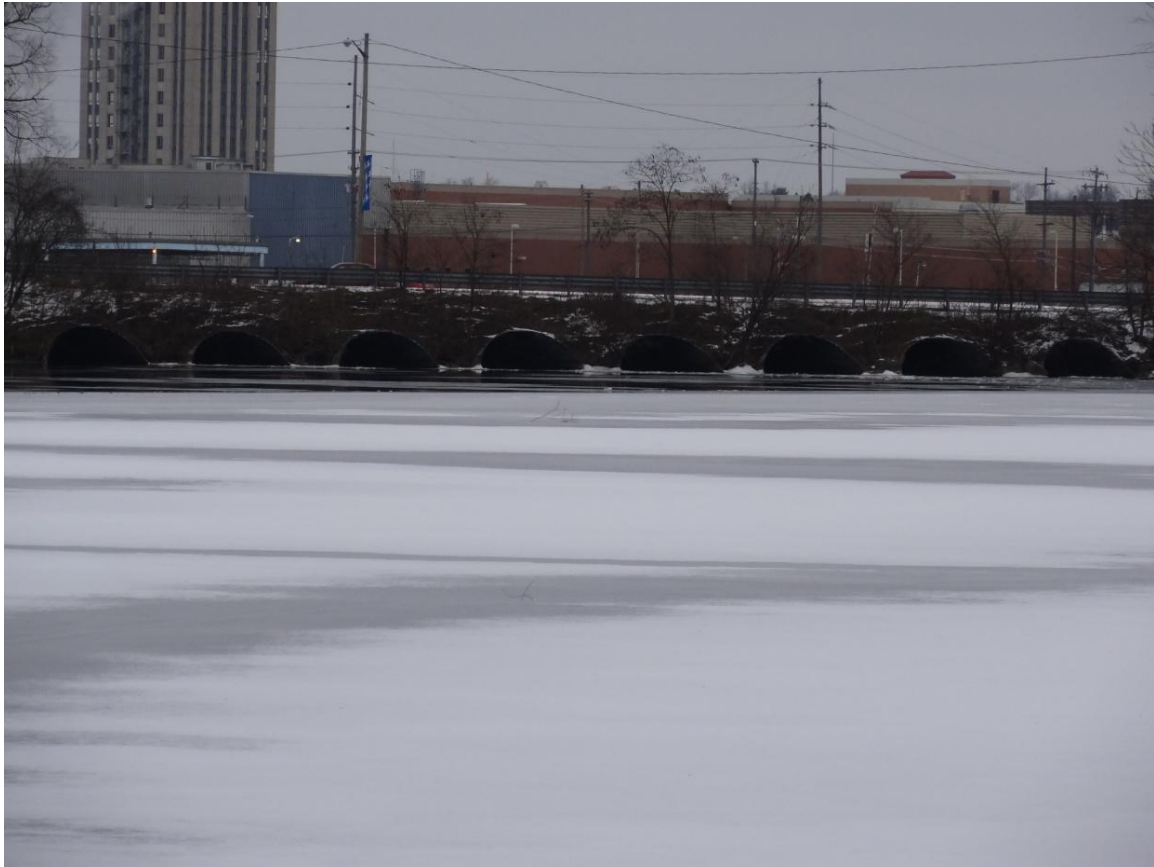
9. MP 15.75 North Mill Pond culverts, frazil ice observed in river channel.

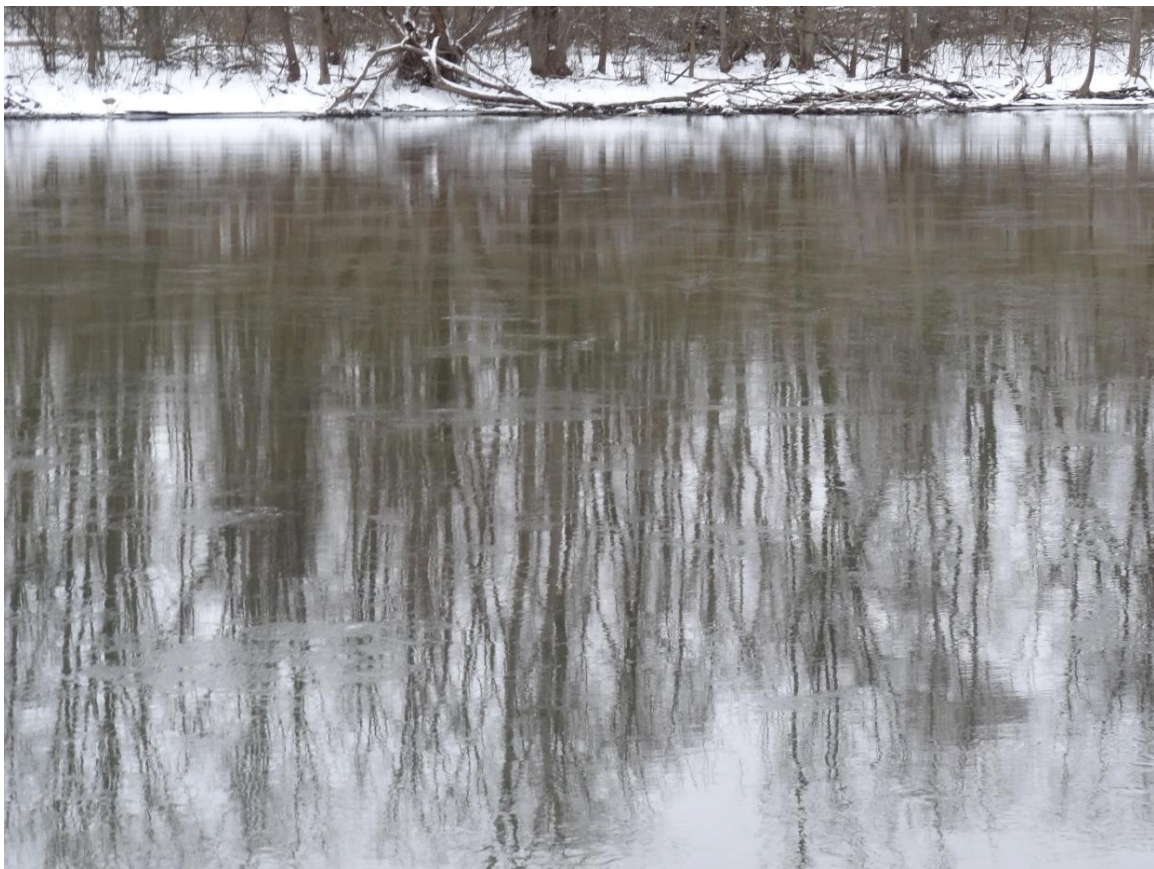
10. D2 Boat Launch, small patches of frazil ice observed flowing downstream in river channel.

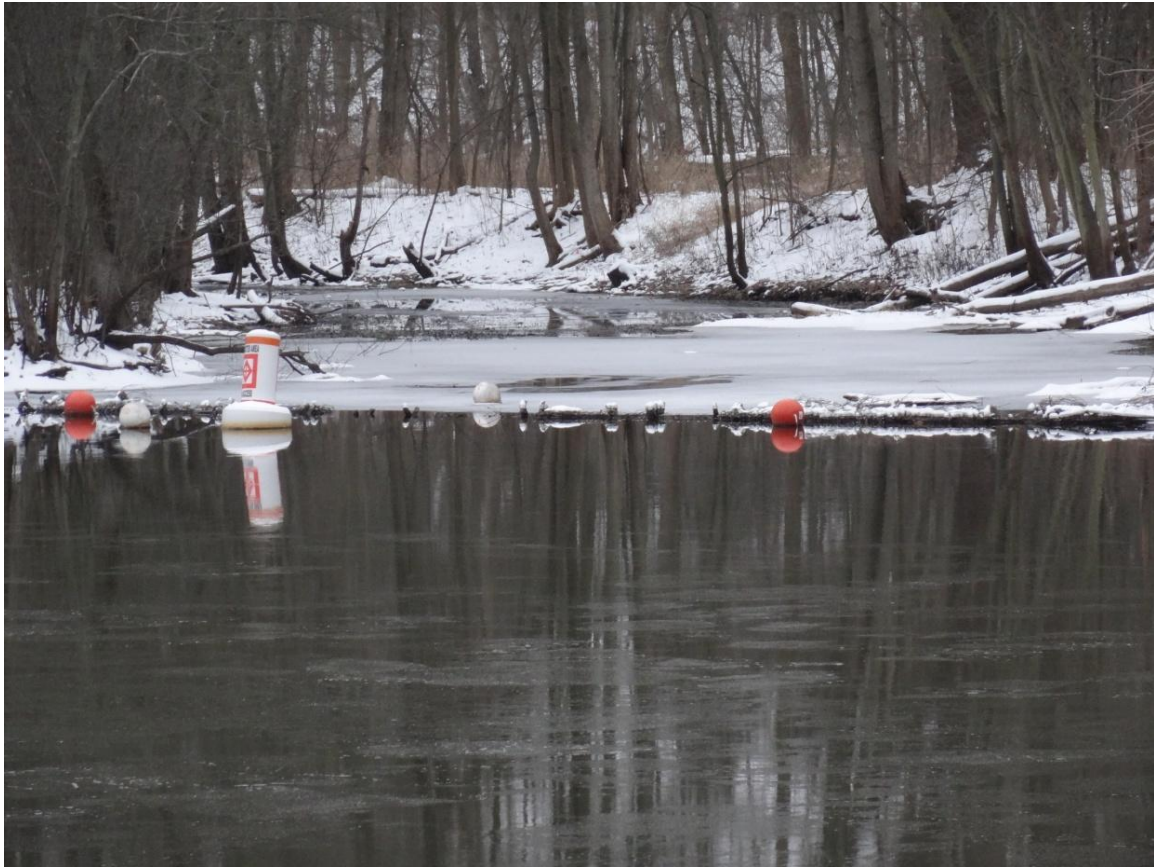
11. MP19.50 LDB Sediment Trap. Snow and ice observed in backchannel.

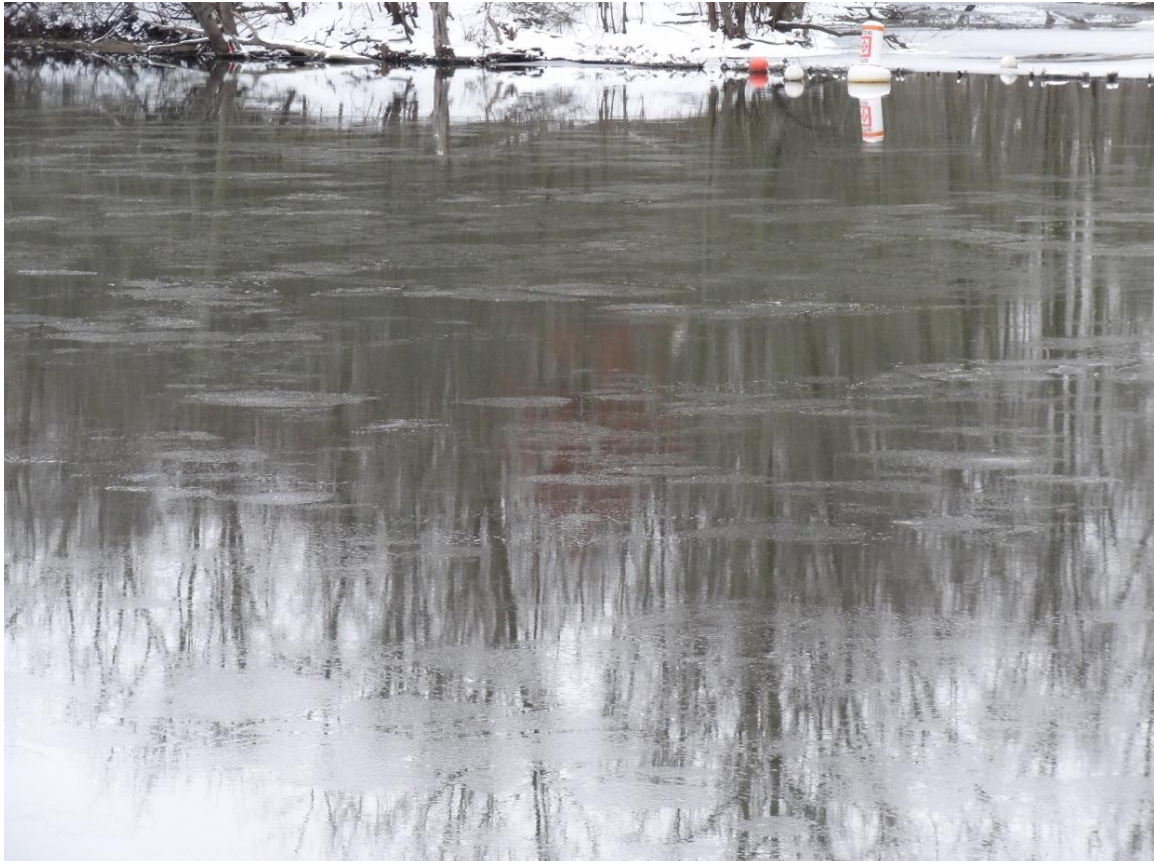
12. MP19.50, frazil ice observed flowing downstream in river channel.

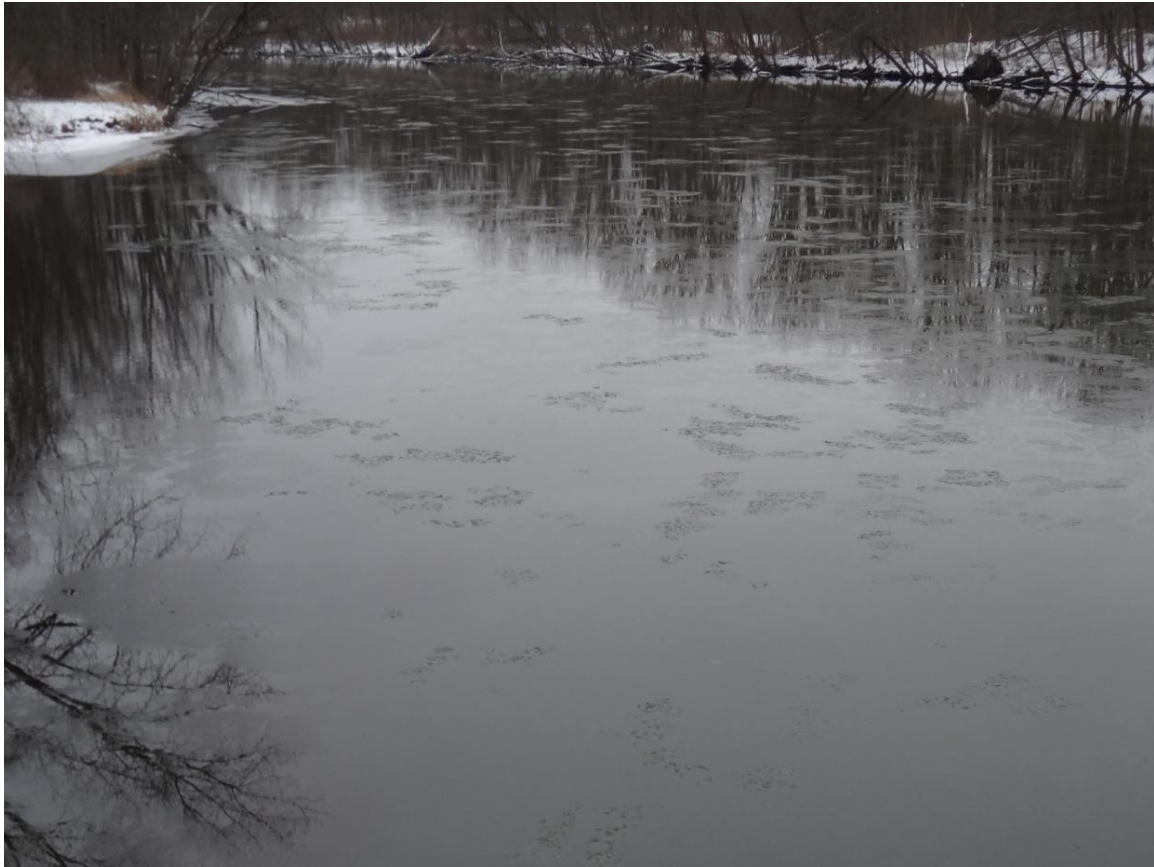
13. MP21.50, frazil ice observed flowing downstream in river channel.

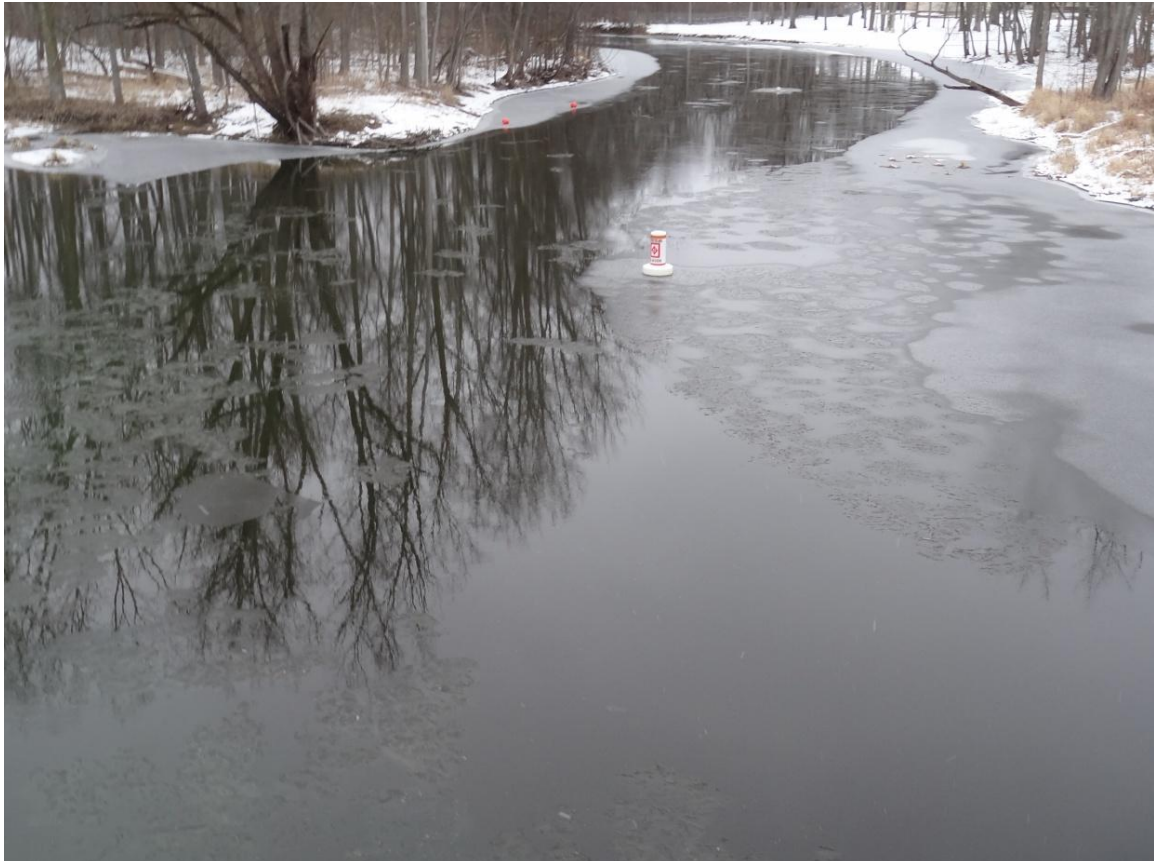
14. MP21.50 RDB, frazil ice observed flowing into back channel of oxbow.

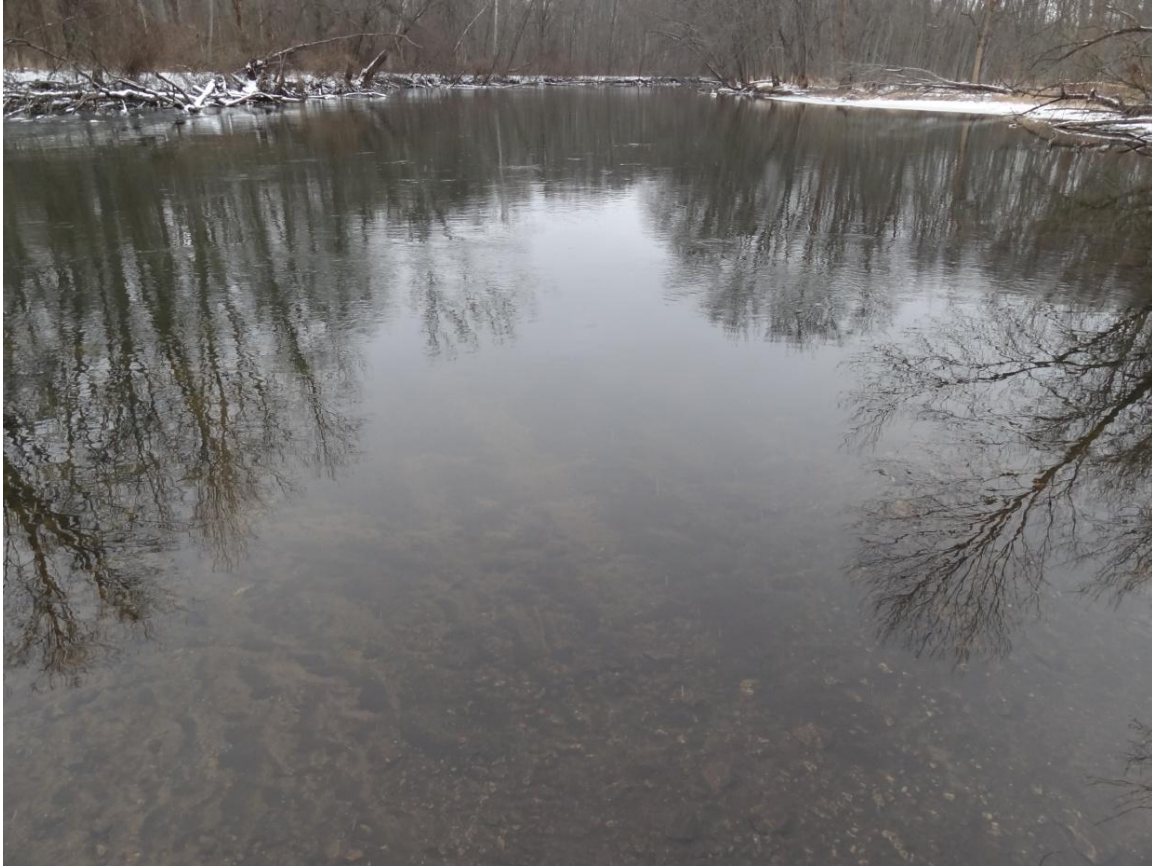
15. E2 Boat Launch. No sheen, frazil ice or bank ice observed.

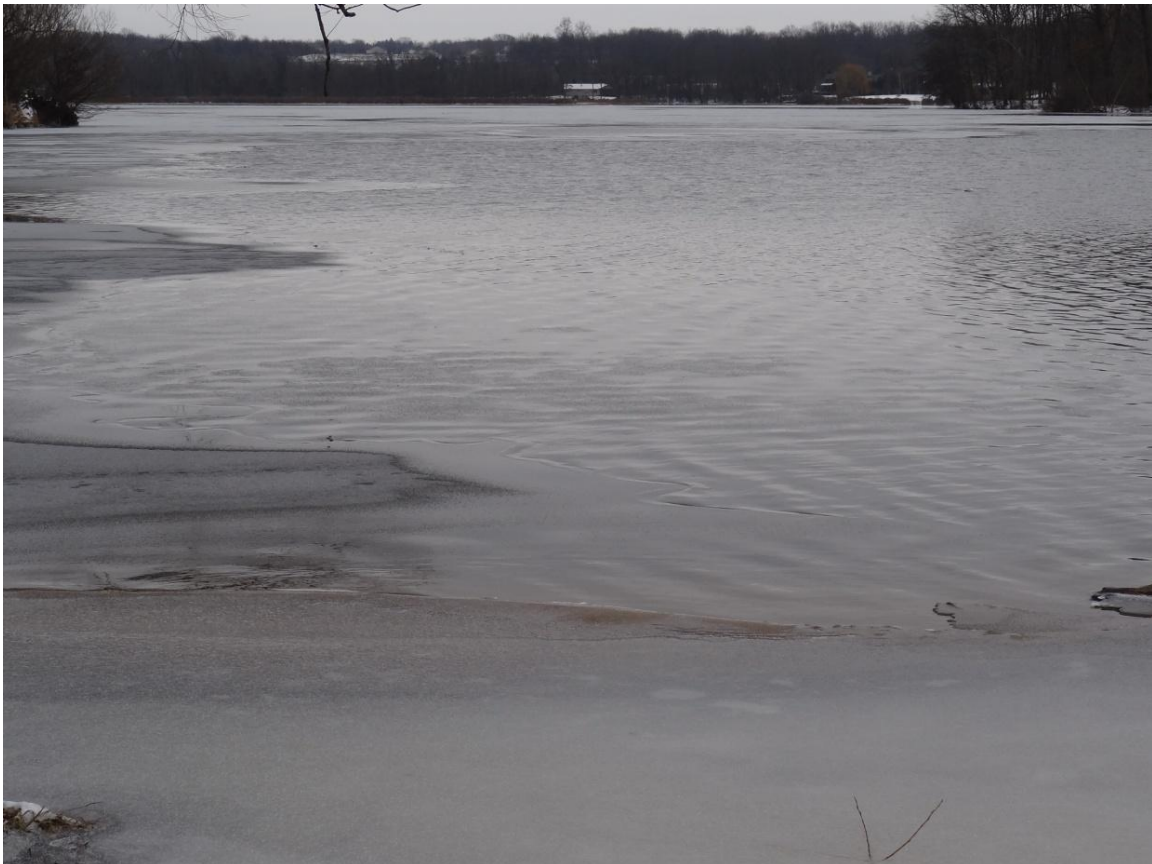
16. Former E4 boom location looking east into Delta. Minor bank ice observed.

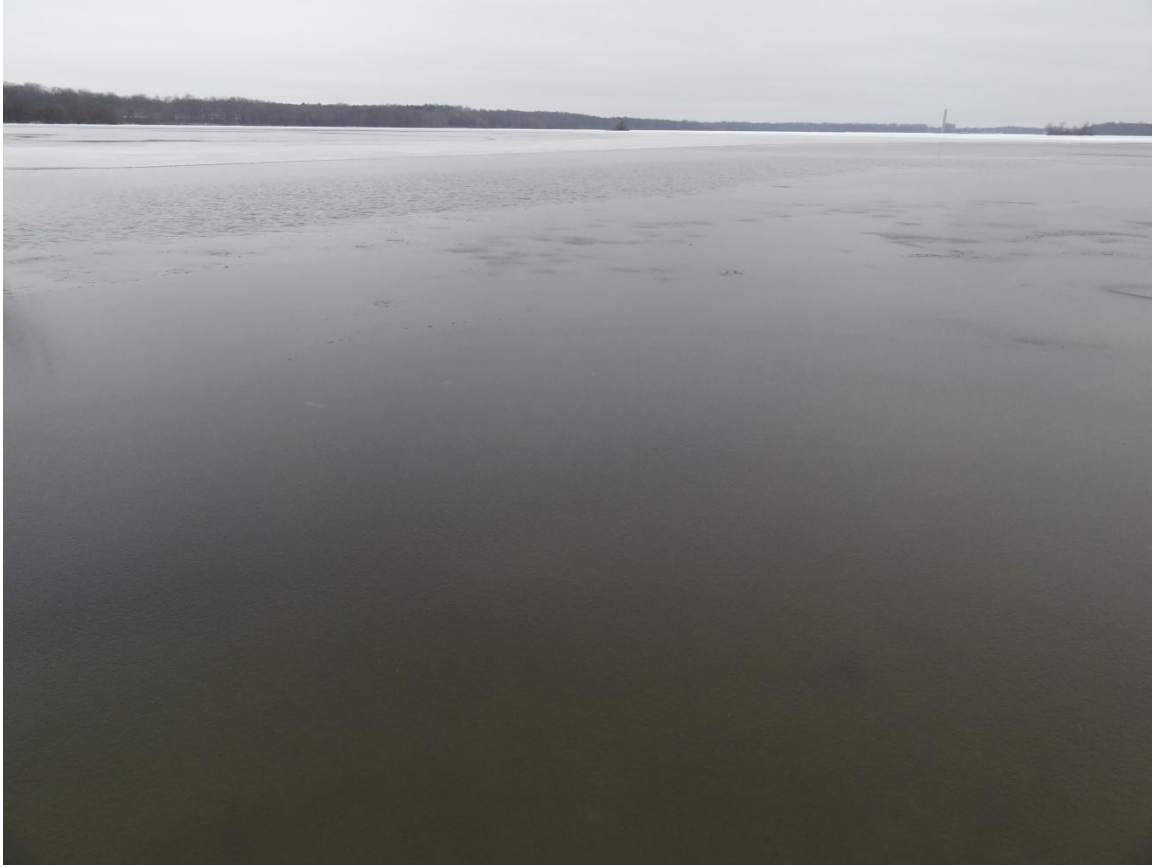
17. E4 Boat Launch looking southwest. Ice has receded in southern portion of Morrow Lake.

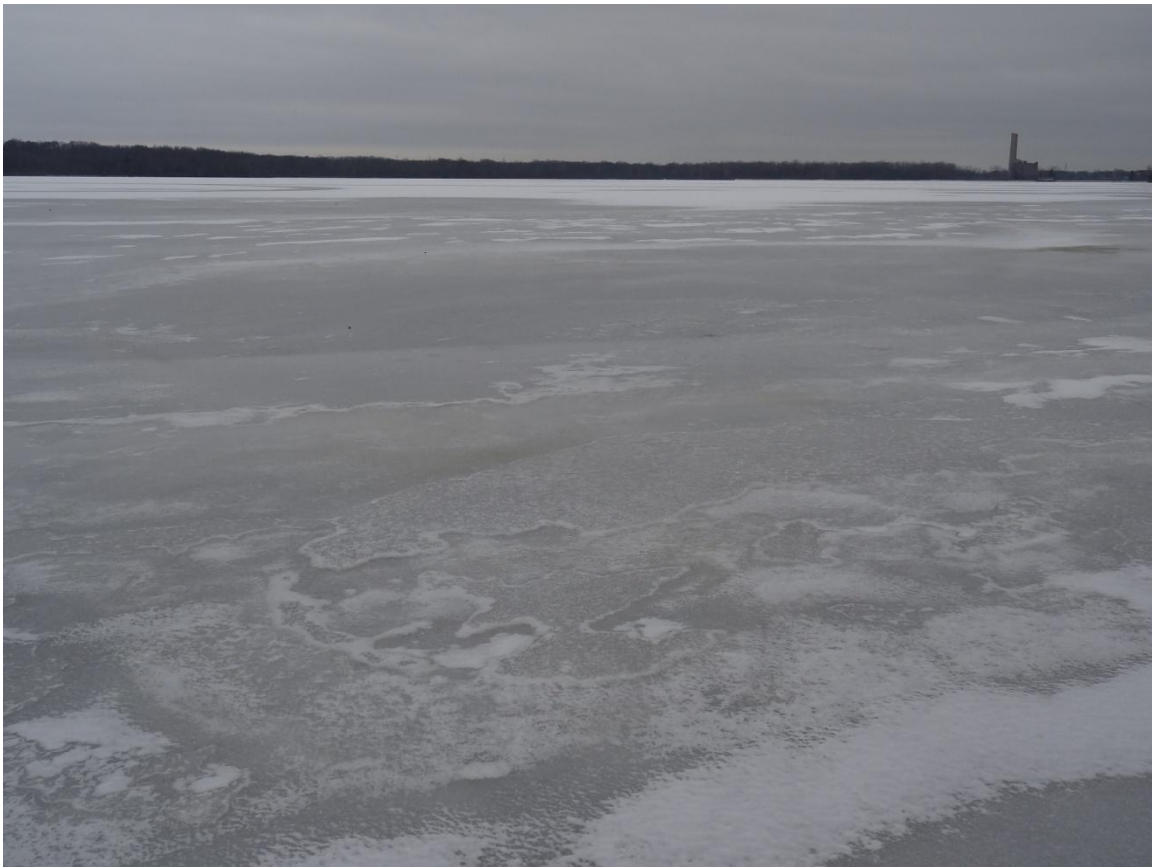
18. E4.5 Boat Launch. West end of Morrow Lake remains covered in snow and ice.
